**TECHNICAL ANALYSIS AND SUMMARY
PILOT SCALE DEMONSTRATIONS**

**NATURAL RESOURCES CANADA
GREEN CONSTRUCTION THROUGH WOOD PROGRAM**

GHL File 8000.03

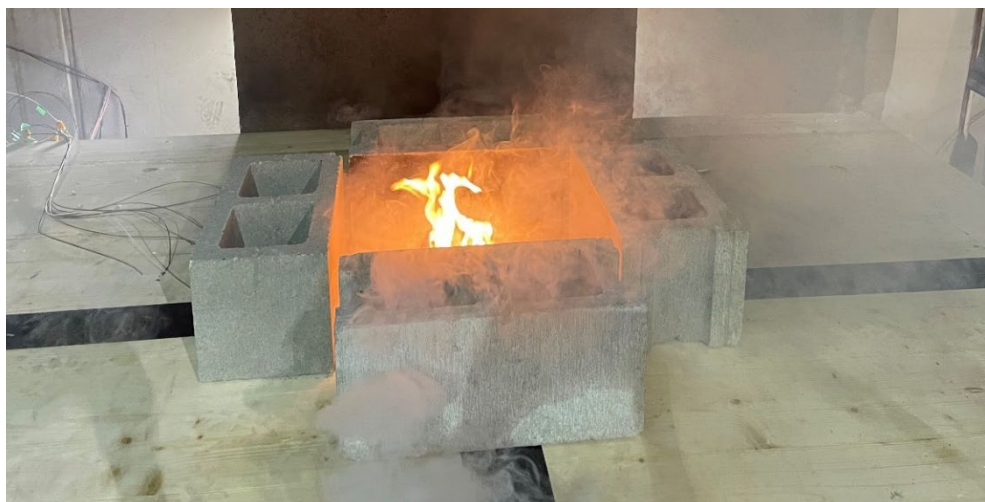
During the test, open flame was observed on the unexposed side of the panel near the centre steel tubing area at approximately 50min after the test started, as shown in Figure 3. Review of the temperature measurement at TC 2 and TC 3 indicated that there was a temperature differential at the steel-timber interface at the centre tubing area compared with the one adjacent threaded rod. This increase may have resulted from the larger air gap between the centre tube and timber panel due to the hand fabrication of the panels by trades at field. The edges of panels could not tightly fit with the steel component as illustrated in Figure 4. After consulting with industry partners, it is noted that the panel would typically be prepared by automatic fabrication such as CNC system in factory. Therefore, the air gap on an actual construction site may not be as significant as the ones prepared for this test. It is in our opinion that the tested condition with large air gap presents a conservative scenario with respect to the charring and thermal performance.

Figure 3. Photo of the open flame at centre of the panel on the unexposed side

It is noted that the perimeter of the steel components on the unexposed side was fire caulked during the test to extinguish the flame during the test and minimize further burning. Further, to minimize the potential open flame situation, the remainder of the test specimens were prepared with caulking and Type X gypsum board on the unexposed side.

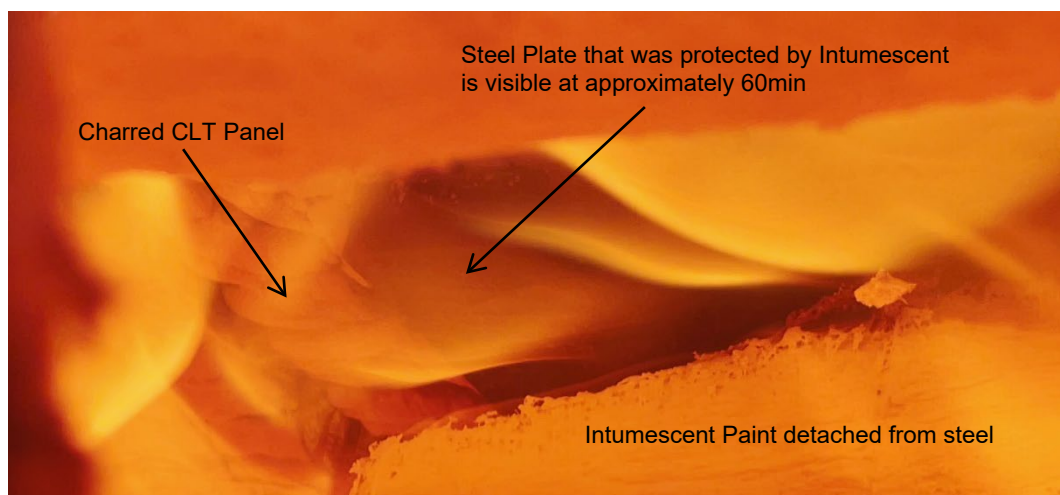
The exposed steel components in this specimen were provided with a ULC listed 2h rated intumescent paint following appropriate application. It was expected that this design would perform similar to other typical 2h listed design. The paint started to expand in the early stages of the fire test at around 5min. At approximately 20min, significant flame was observed at some of the expanded locations. Later, cracks appeared where flame was observed, and paint started to deform and lost its ability to remain in place. At approximately 70min, the bottom of the steel plate was fully exposed, as shown in Figure 5. This detachment of the intumescent paint was unexpected, as the listed design was intended for 2h application. After this test, we consulted with several industry partners on this situation; it is unknown what contributed to the detachment of the paint.

Figure 5. Screen shot of specimen 3 video illustrating the exposed steel component

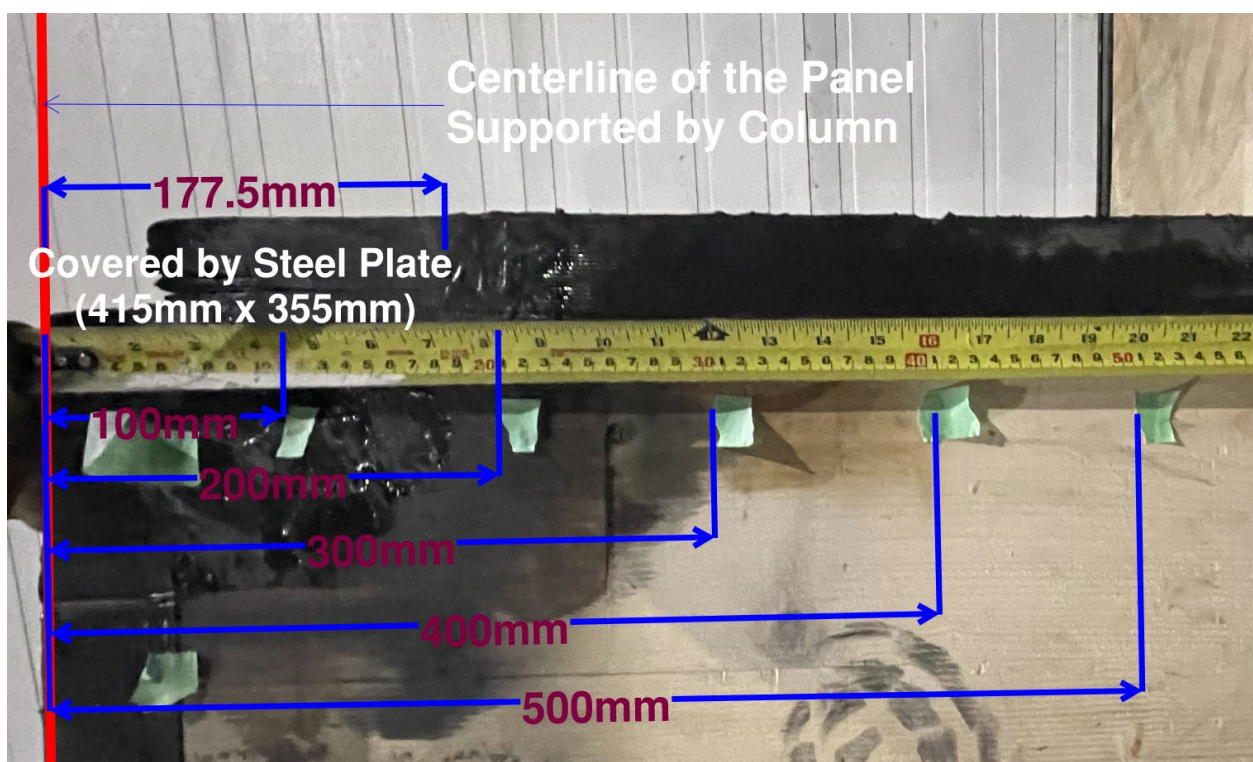
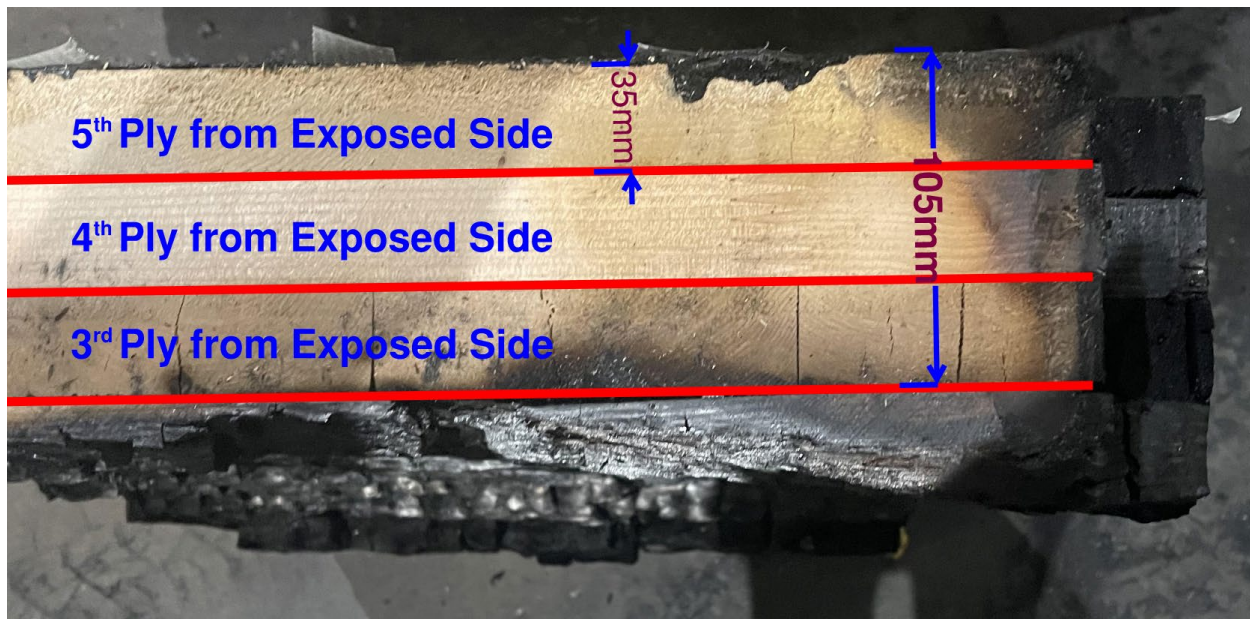
It is noted that the first measurement, which is 100mm from the centre line of the panel, was within the timber space covered by the steel plate, as shown in Figures 6 and 7. The average char rate at these steel-timber interfaces are included in Table 5.

Figure 6. Photo illustrating the post-test measurement of clt panel

Figure 7. Photo of the cut section of test specimen 1

The exposed steel design has the fastest char rate of average 0.7mm/min. This was expected given the amount of exposed steel component presented. However, this char rate is still close to the value currently included in Annex B of CSA O86 for determining the fire resistance rating of the mass timber design and provides a level of confidence for future applications. It is noted that this is a lightly loaded condition.

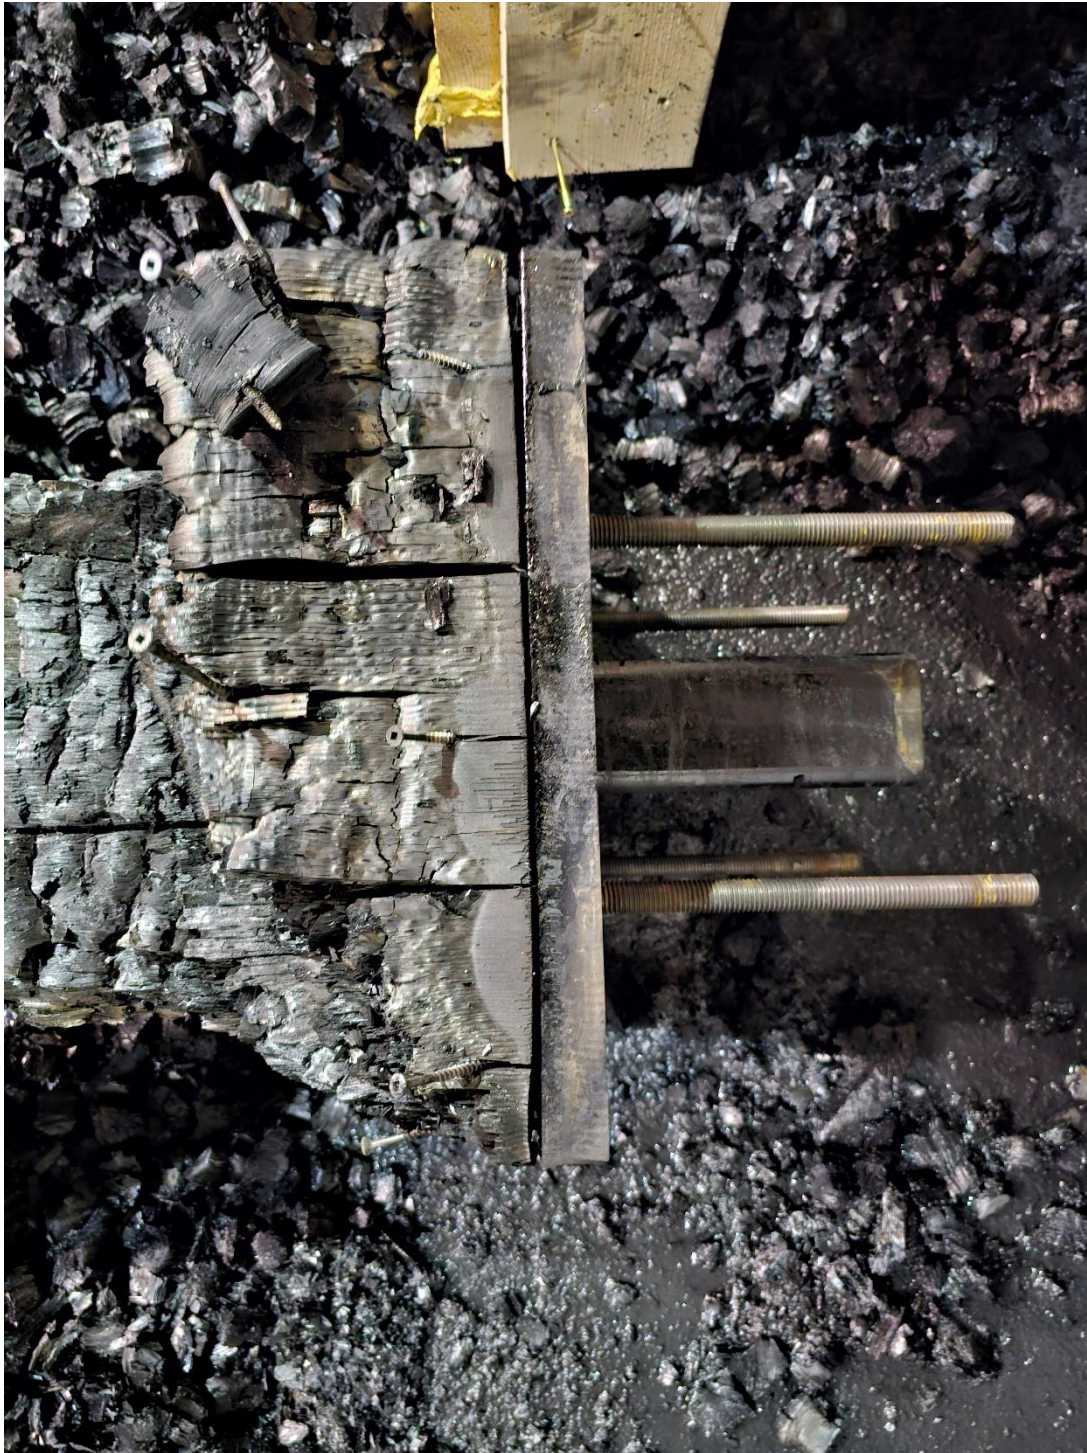
Figure 11: Glulam column and steel connection after fire exposure.

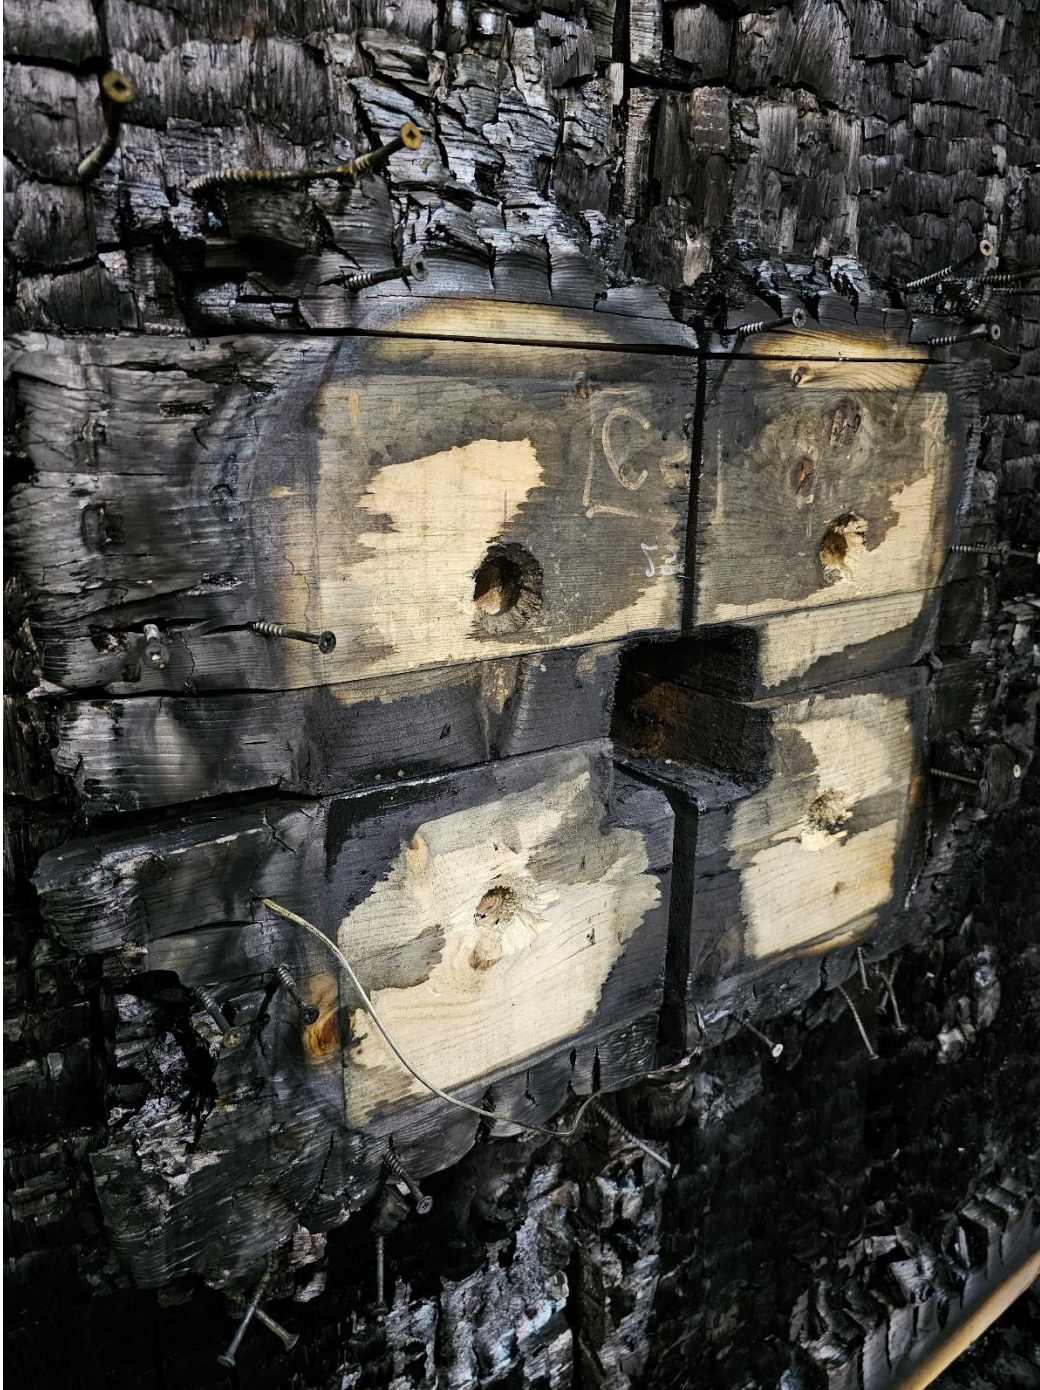
Figure 12: Localized damage through steel column 3 inch x 3 inch steel tube penetration through the CLT assembly.

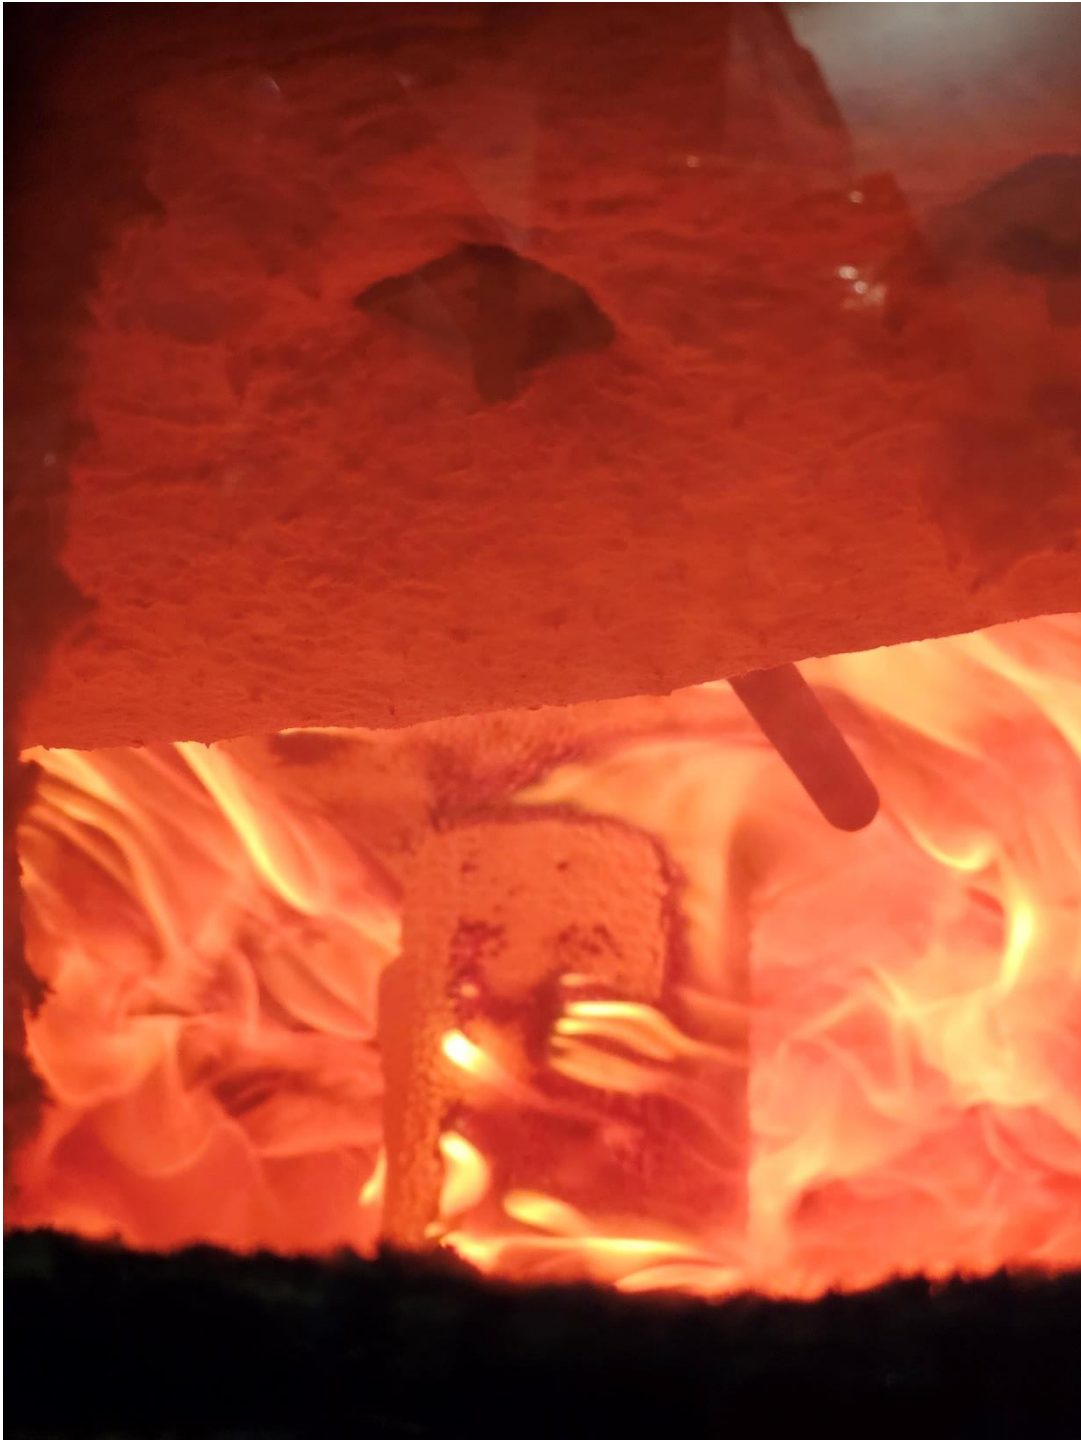
Figure 9. CLT Assembly with Intumescent Paint Protected HSS Steel Column During Fire Exposure, Paint Flaming Shown

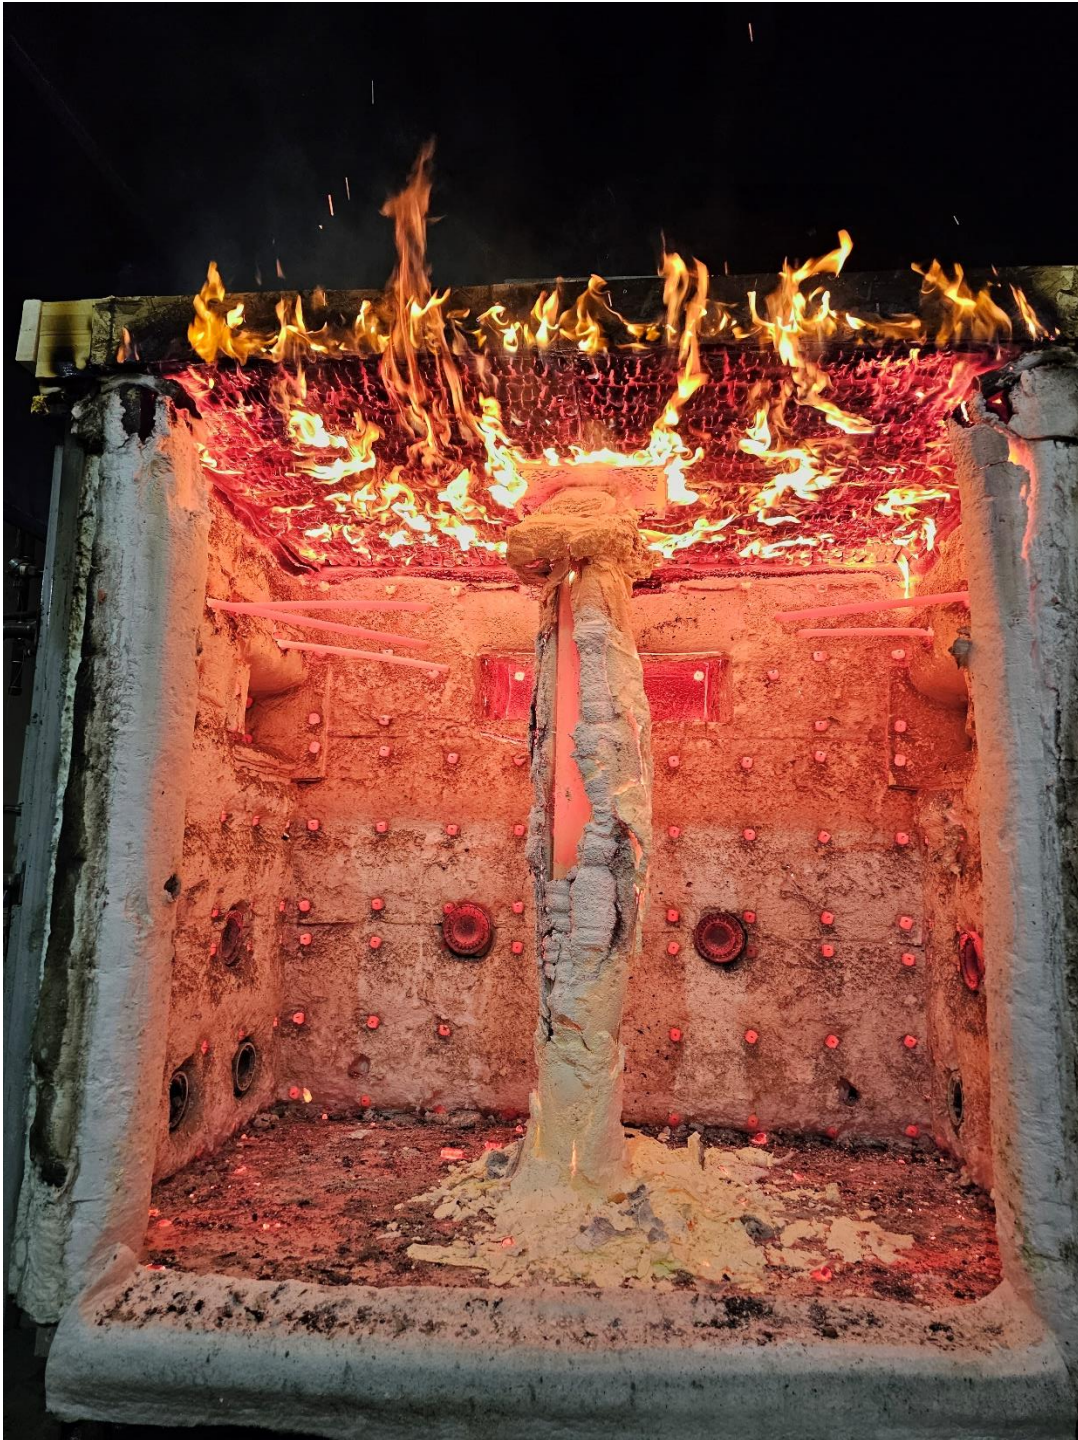
The intumescent painted column had an average char rate of 0.43mm/min at the steel-timber interface. As the design was following a ULC listed 2h fire rated design and was applied in a factory, it was expected that this specimen would have a similar char rate of other listed 2h design such as the GWB protection. This increased char rate may come from the fact that the intumescent paint cracked and significant portions fell off prior to termination of the test. A future study on the performance of the intumescent painted steel design should be conducted to further investigate the appropriate design.

Figure 10. CLT with Intumescent Paint Protected HSS Steel Column After Fire Endurance Exposure, Exposed Steel Evident Along HSS Edge

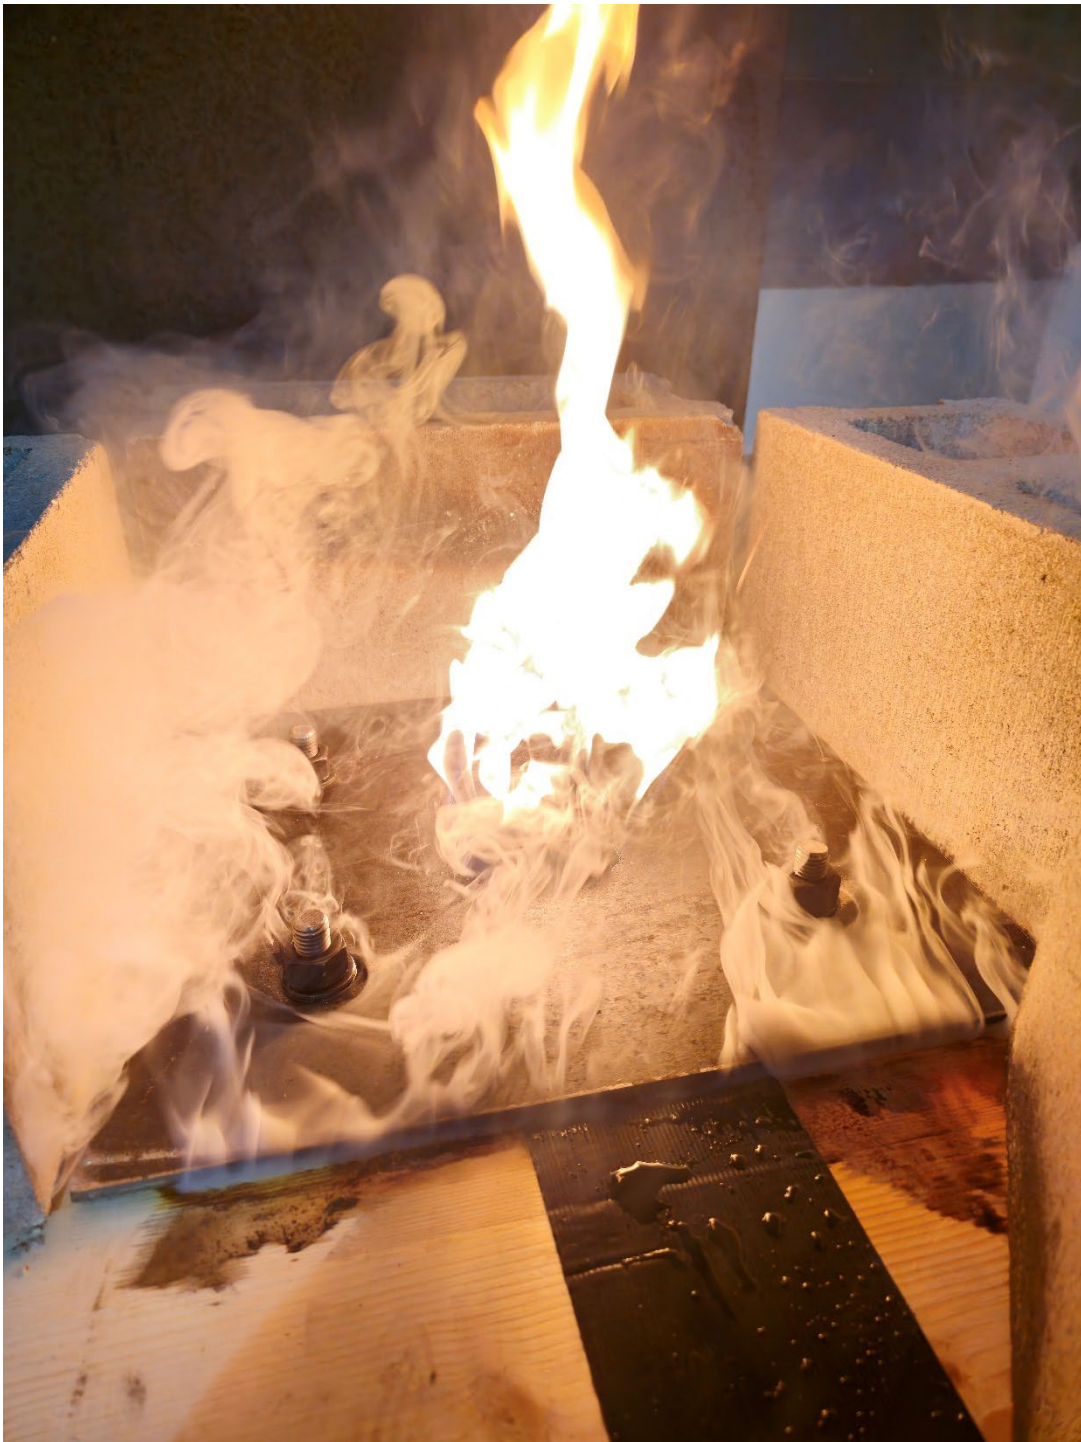
Figure 8: Flaming non-fire side through and around 3 inch x 3 inch steel tube (including concrete masonry weight)

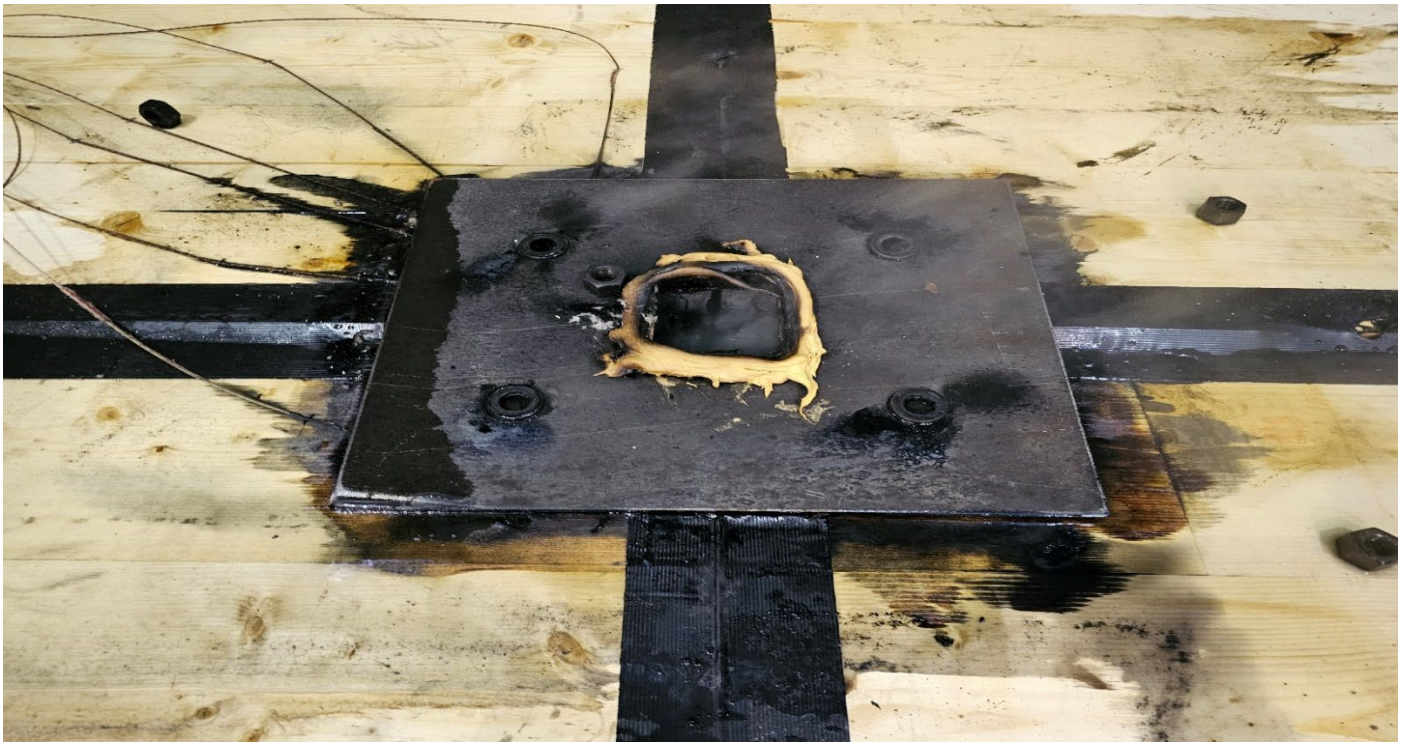
Figure 9: Steel column non-fire side after fire caulking around perimeter.

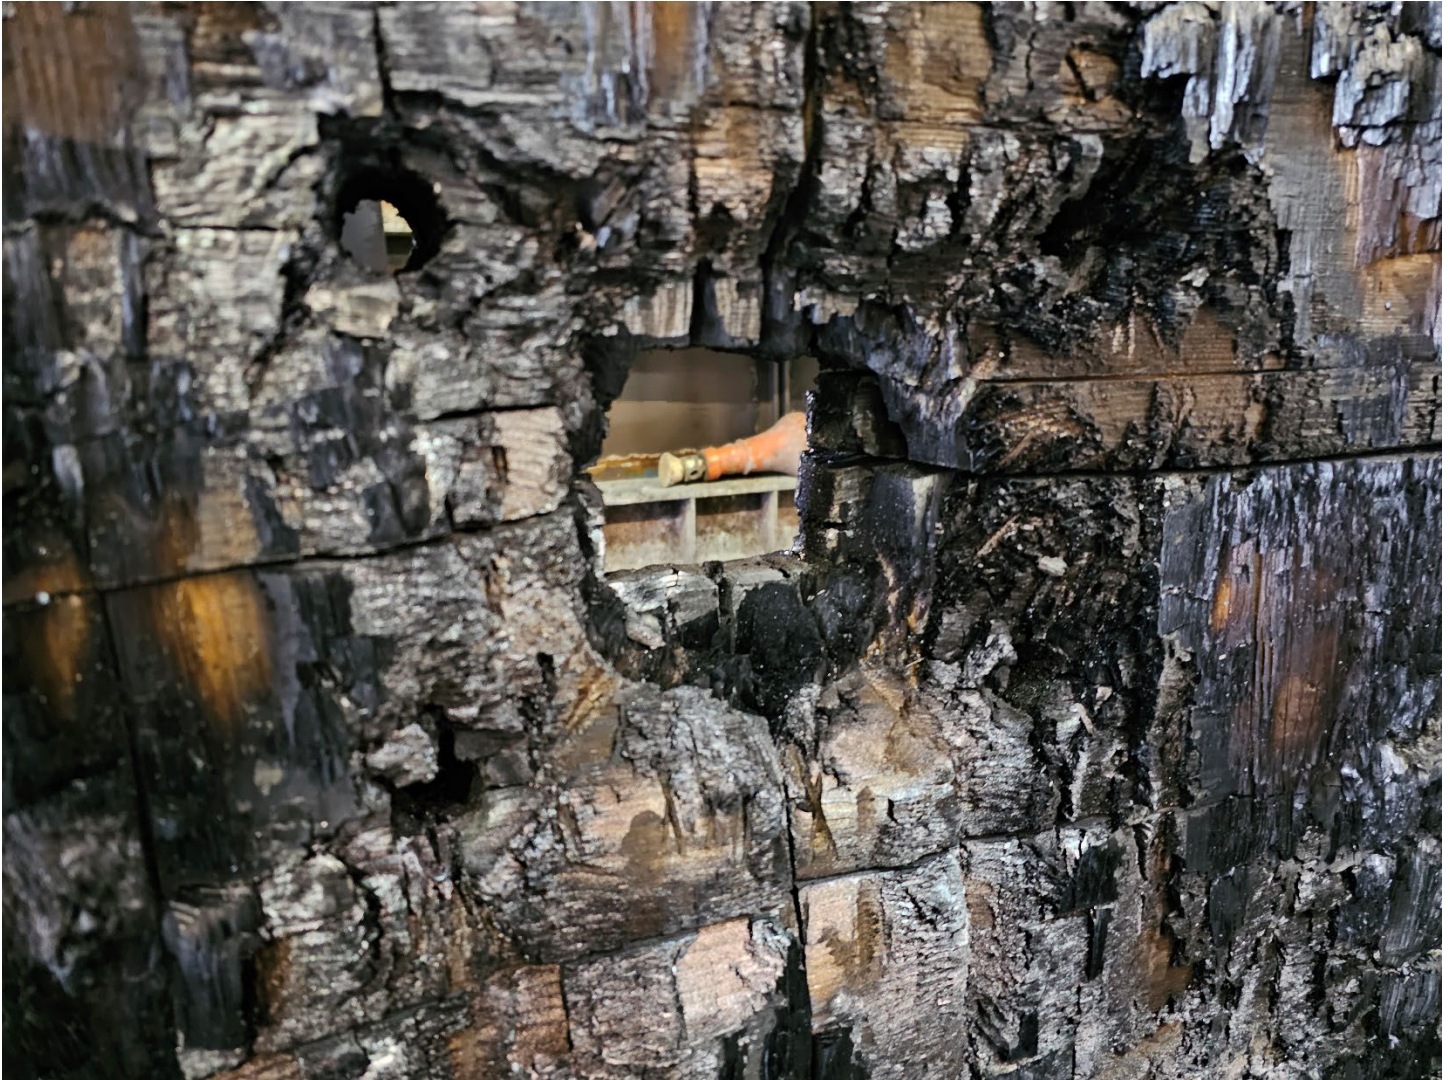
Figure 12. Localized damage through steel column 3 inch x 3 inch steel tube penetration through the CLT assembly.

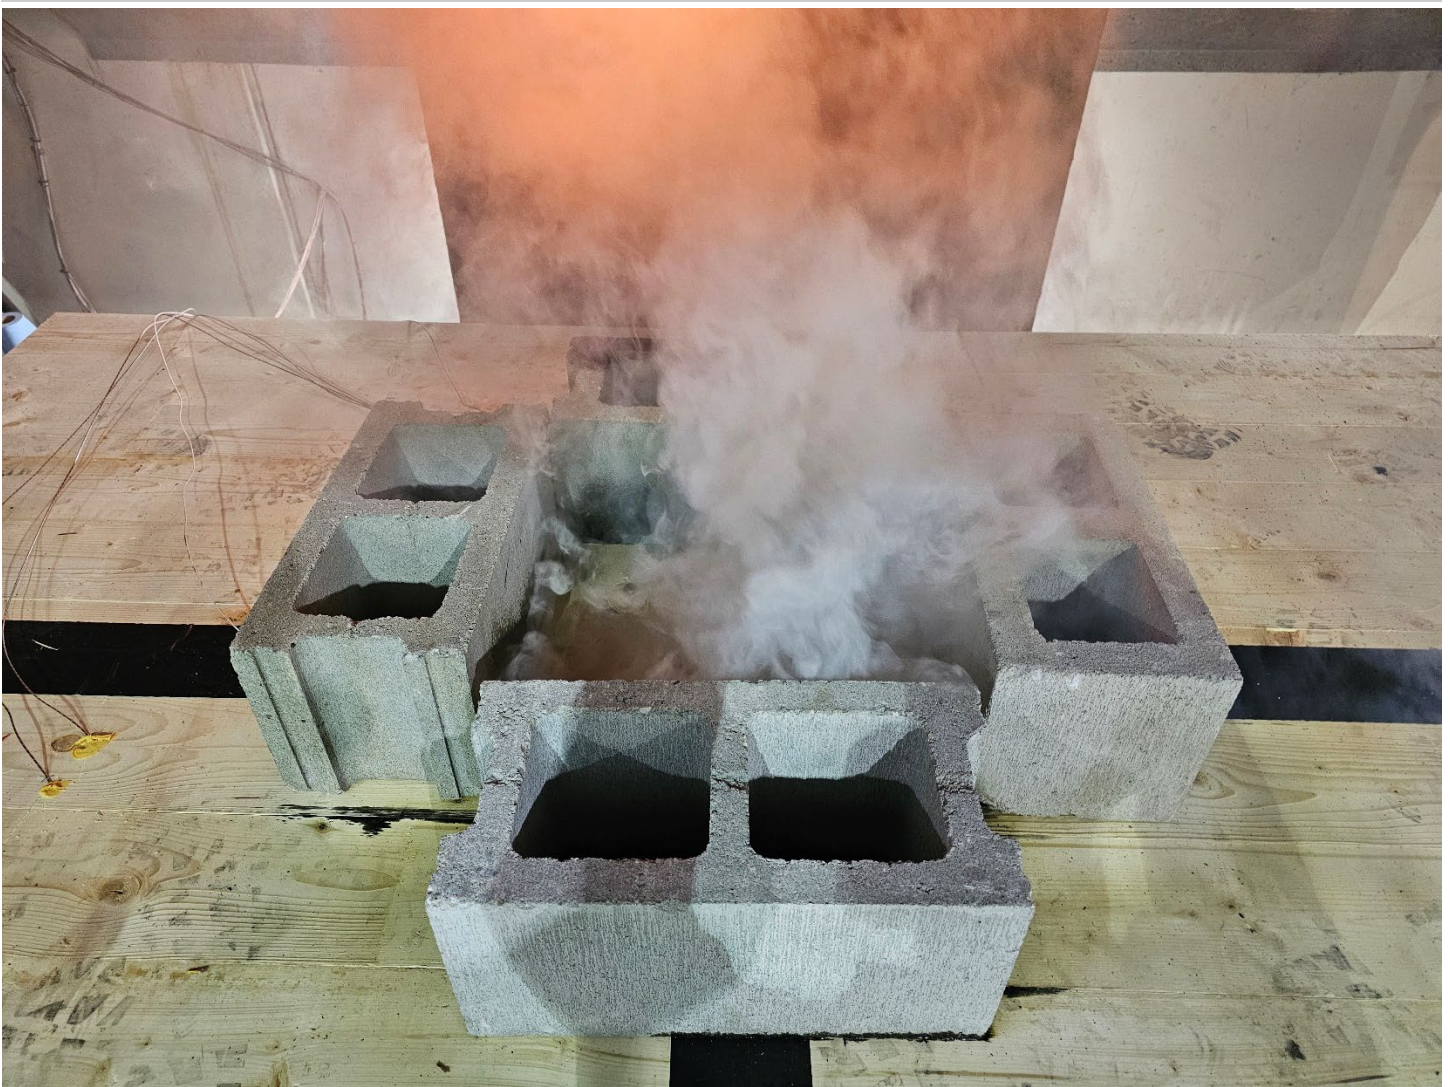
Figure 8: Observed smoking non-fire side (including concrete masonry weight)

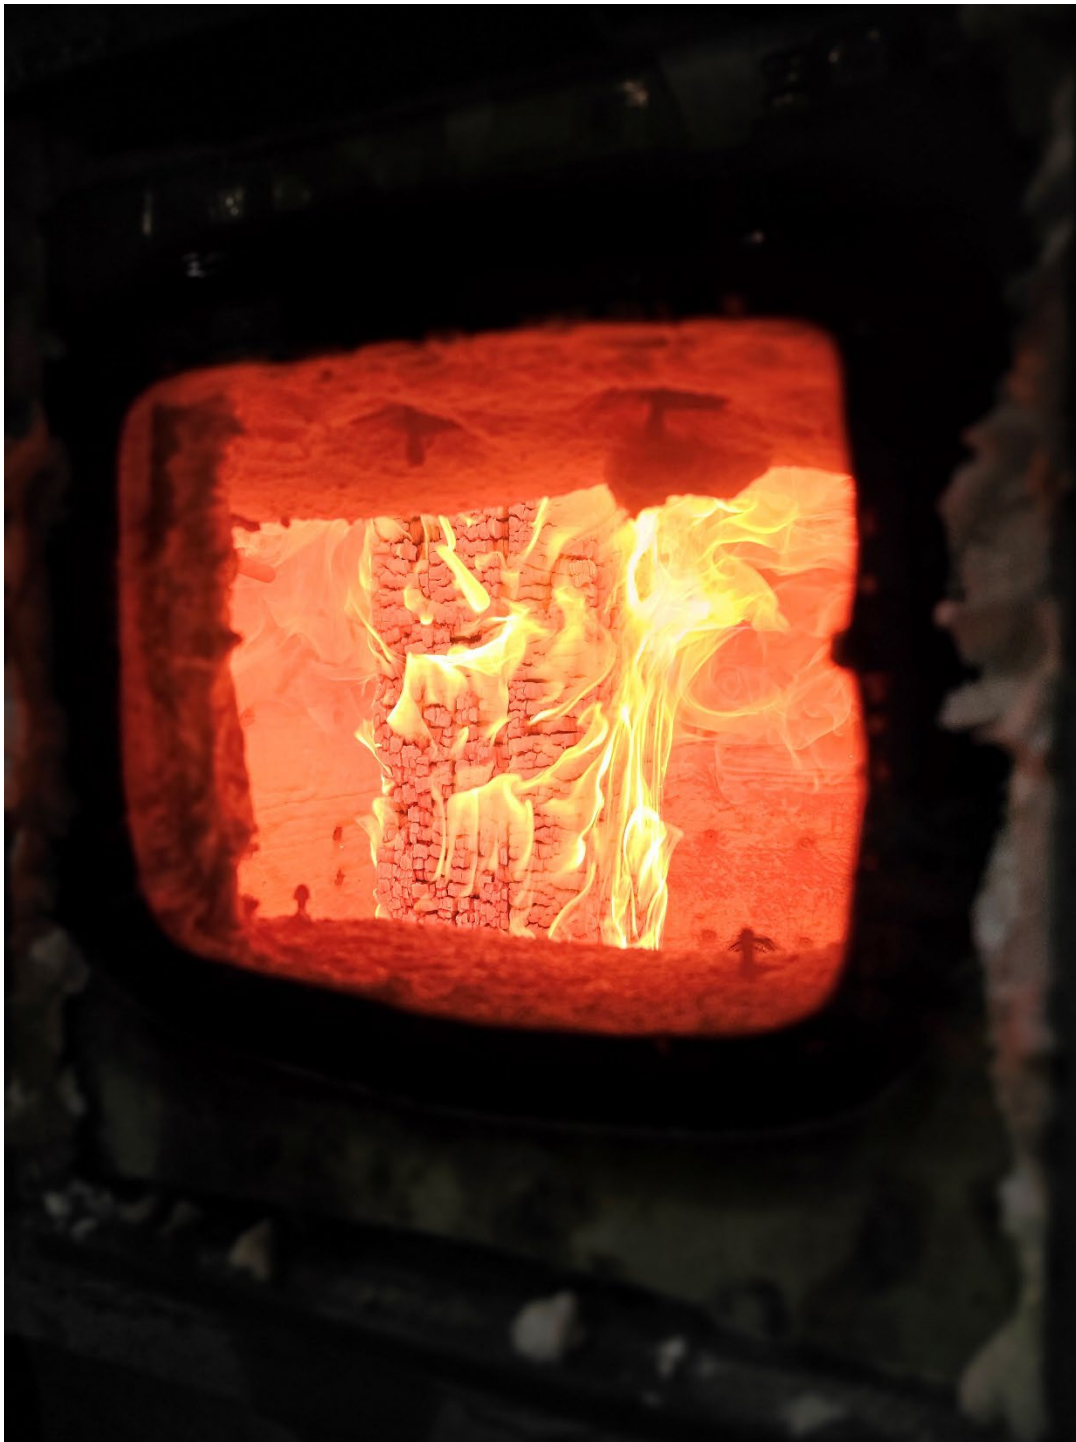
Figure 9: Glulam column showing char development during fire endurance exposure.

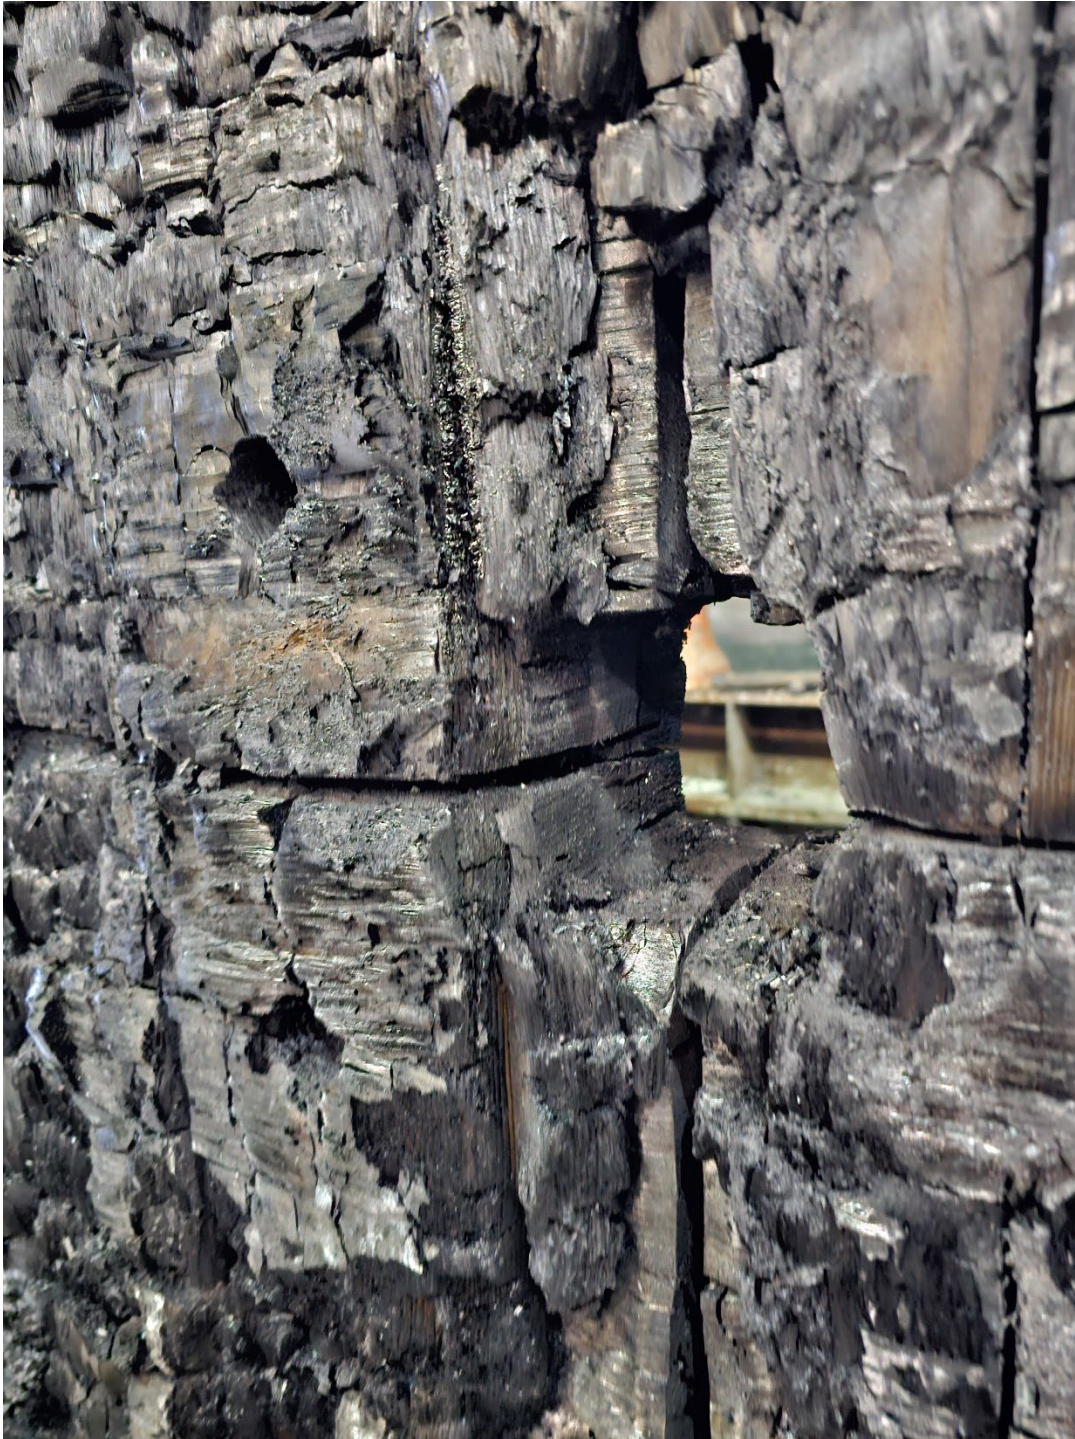
Figure 12. Localized damage through steel column 3 inch x 3 inch steel tube penetration through the CLT assembly.
