ENCAPSULATED MASS TIMBER CONSTRUCTION CHAR RATE ANALYSIS

NATURAL RESOURCES CANADA GREEN CONSTRUCTION THROUGH WOOD PROGRAM

March 31, 2020

GHL File 6924.01

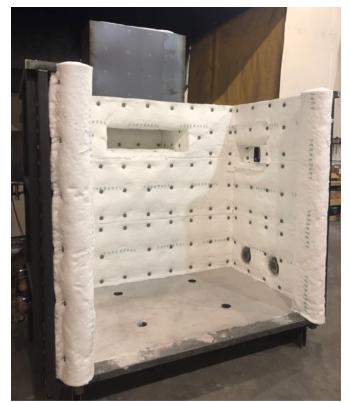
The furnace used in the tests is a pilot-scale fire burning apparatus with interior dimensions of 1.78 m (70 in.) in height, 1.91 m (75 in.) in width, and 1.30 m (51 in.) in depth.

Temperatures within the furnace were monitored using four thermocouples. The temperatures are controlled by adjusting fuel to the furnace burners to conform to the time/temperature curve specified by the test standards. Temperature measurements are recorded by a Keithley 2750 data acquisition unit (ID# DMM1) which passes the readings to a computer for graphical display and storage.

Figure 1: Pilot-Scale Furnace

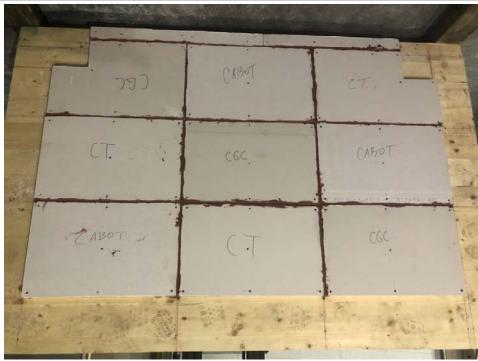
Figure 8: The exposed side of the assembly prior to the fire test.

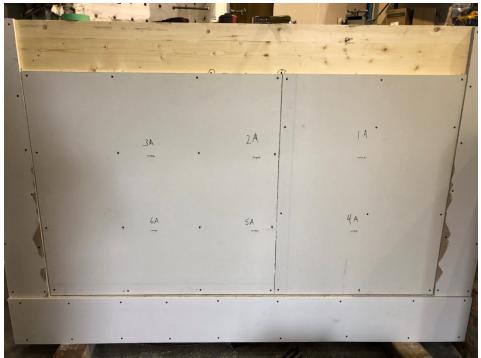
Figure 6: The exposed side of the assembly after the installation of the base layer gypsum.

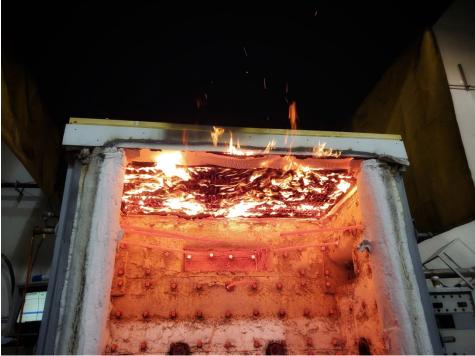
Figure 8: The exposed side of the assembly at the end of the fire test.

Test Time (min)	Unexposed	Exposed
1:32		Ignition of the gypsum paper.
22:30		The back and front edges are sagging between the screws.
30:00		Back right side corner has released from the screw.
36:54		16 in. wide strip through the middle right side of the
30.34		face layer has fallen.
41:11		Another 16 in. wide section has fallen.
43:16		Another 16 in. wide section has fallen on the left side.
49:09		Gypsum piece has fallen from the left side.
55:40		Flaming at the base layer gypsum joint.
58:30		Flaming from cracks in the base layer.
62:20		Right side piece of face layer has fallen.
75:00		Large section of the base layer has fallen.
120:00	Test	discontinued.

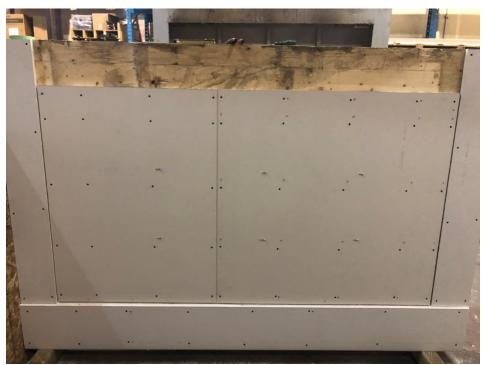
Figure 7: The exposed side of the assembly after the installation of the base layer.

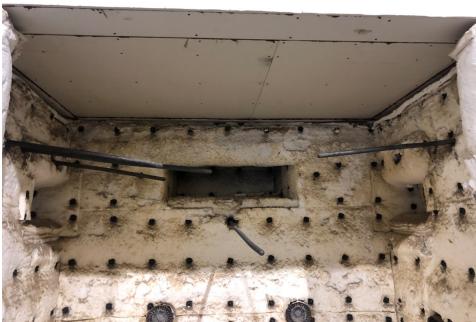
Figure 8: The exposed side of the assembly prior to the fire test.

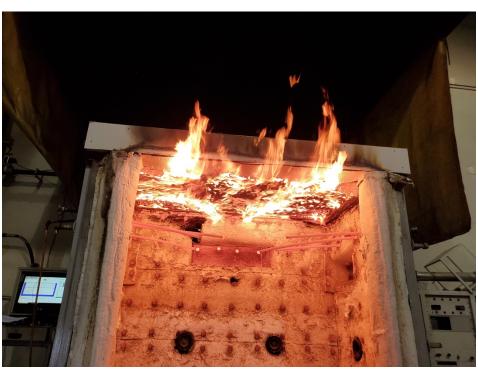
Figure 9: The exposed side of the assembly after the fire test.

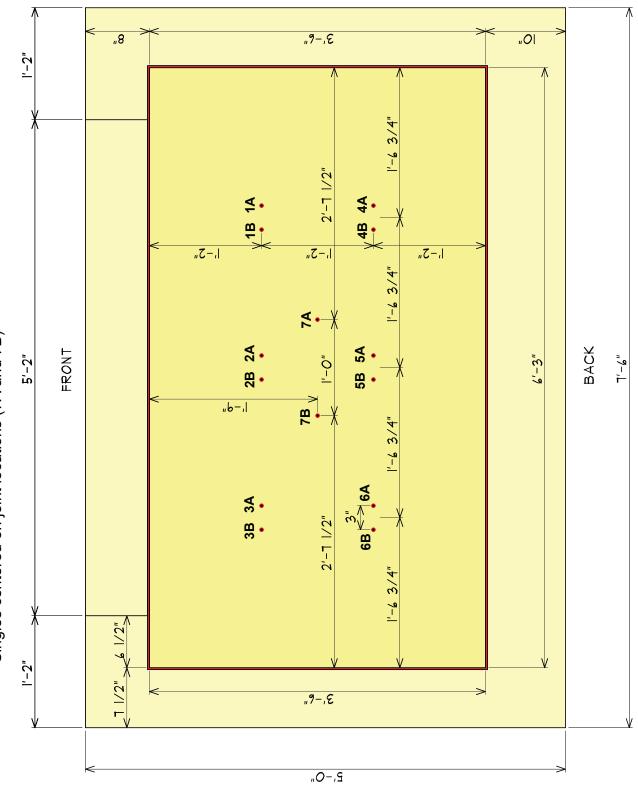
TC HOLES Test 3

TC Holes • Diameter = 1/8" In pairs 3" apart at 1/3 short dimension & 1/4 long dimension (1A, 1B, 2A... 6B, 6B) Singles centered on joint locations (7A and 7B)
