**TECHNICAL ANALYSIS AND SUMMARY
PILOT SCALE DEMONSTRATIONS**

**NATURAL RESOURCES CANADA
GREEN CONSTRUCTION THROUGH WOOD PROGRAM**

GHL File 8000.03

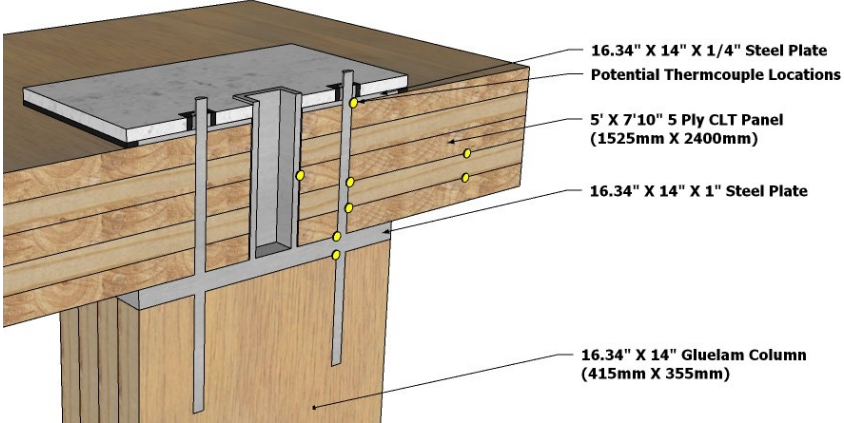
Specimen	Protection	Sketchup
<p>Specimen 4 Exposed Steel-Glulam Column</p>	<p>None</p>

<p>16.34" X 14" X 1/4" Steel Plate Potential Thermcouple Locations</p> <p>5' X 7'10" 5 Ply CLT Panel (1525mm X 2400mm)</p> <p>16.34" X 14" X 1" Steel Plate</p> <p>16.34" X 14" Glulam Column (415mm X 355mm)</p>
<p>Specimen 5 Wood Protected Steel - Glulam Column</p>	<p>Wood Cover conforming to Technical Report No.10</p>

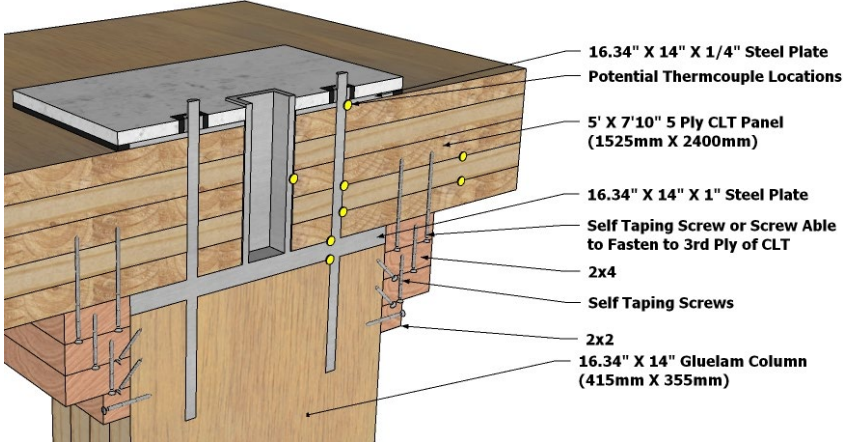
<p>16.34" X 14" X 1/4" Steel Plate Potential Thermcouple Locations</p> <p>5' X 7'10" 5 Ply CLT Panel (1525mm X 2400mm)</p> <p>16.34" X 14" X 1" Steel Plate</p> <p>Self Taping Screw or Screw Able to Fasten to 3rd Ply of CLT</p> <p>2x4</p> <p>Self Taping Screws</p> <p>2x2</p> <p>16.34" X 14" Glulam Column (415mm X 355mm)</p>

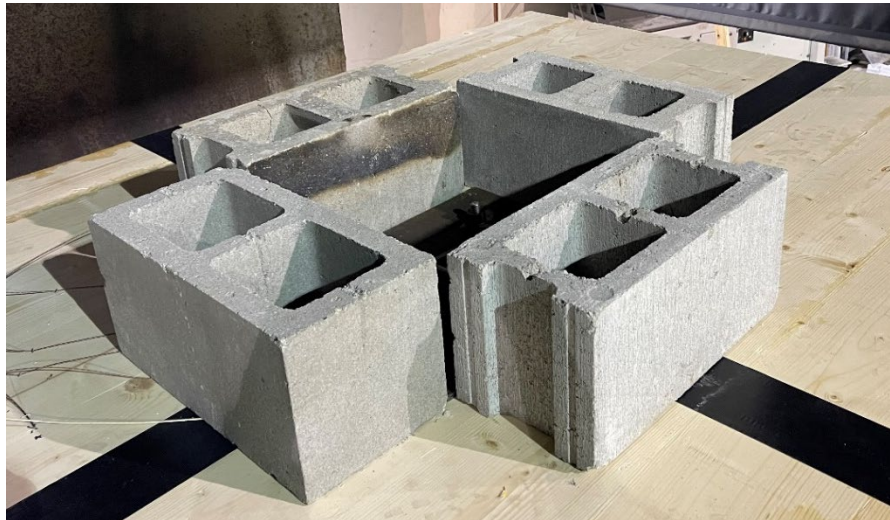
As noted previously, the furnace used in this project is a pilot-scale apparatus; as such, reaction frame with structural loading was not included in this fire test. However, four concrete blocks were placed on the top of the CLT panel around centre, aiming to provide some loading to study the impact of the localized crushing of CLT char at the steel interface.

Figure 1. Concrete blocks on top of panel

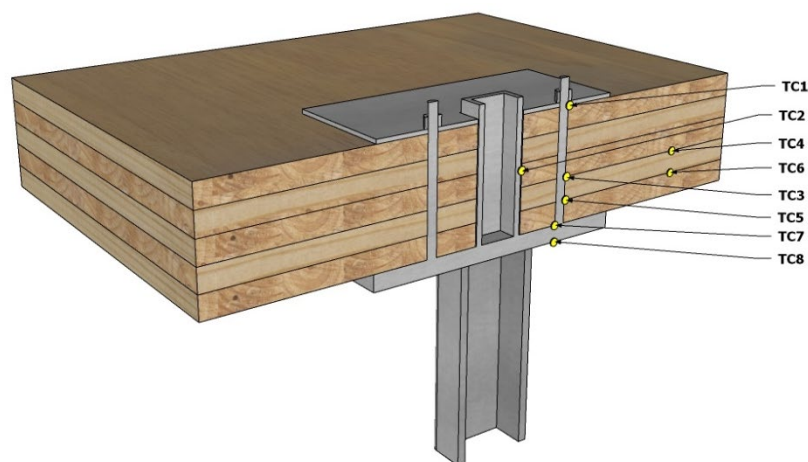
Eight thermocouples were placed inside the test specimens as shown in Figure 2. TC 1 to TC 3, TC 5, and TC 7 to 8 measured the temperature at steel-timber interface. TC4 and TC6 were placed at the glulam of the first and second ply from the exposed side and 500mm from the edge of the panel as a baseline comparison to the temperature measurement at the steel-timber interface of TC3 and TC5, respectively. These thermocouples were installed by QAI Laboratories Inc.

Figure 2. Thermocouple location illustration on typical set up

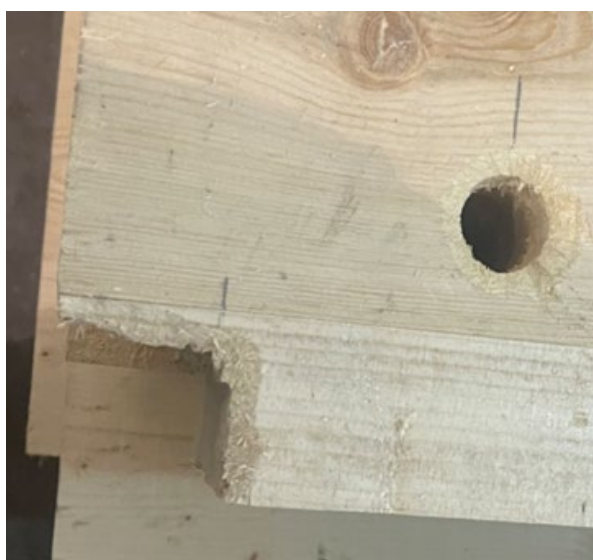
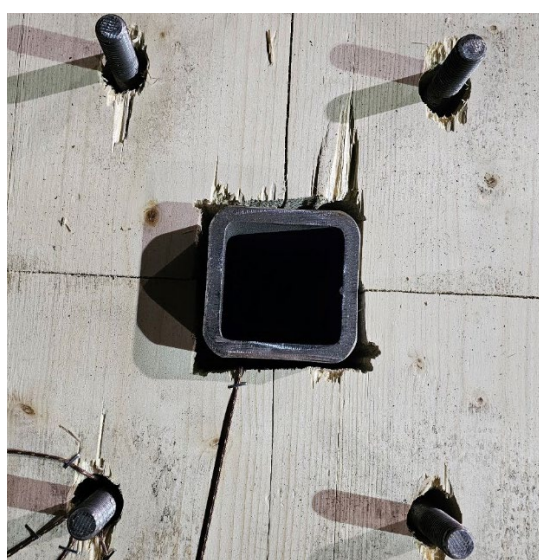
Figure 4. Photos of the panel edge after field fabrication by trades

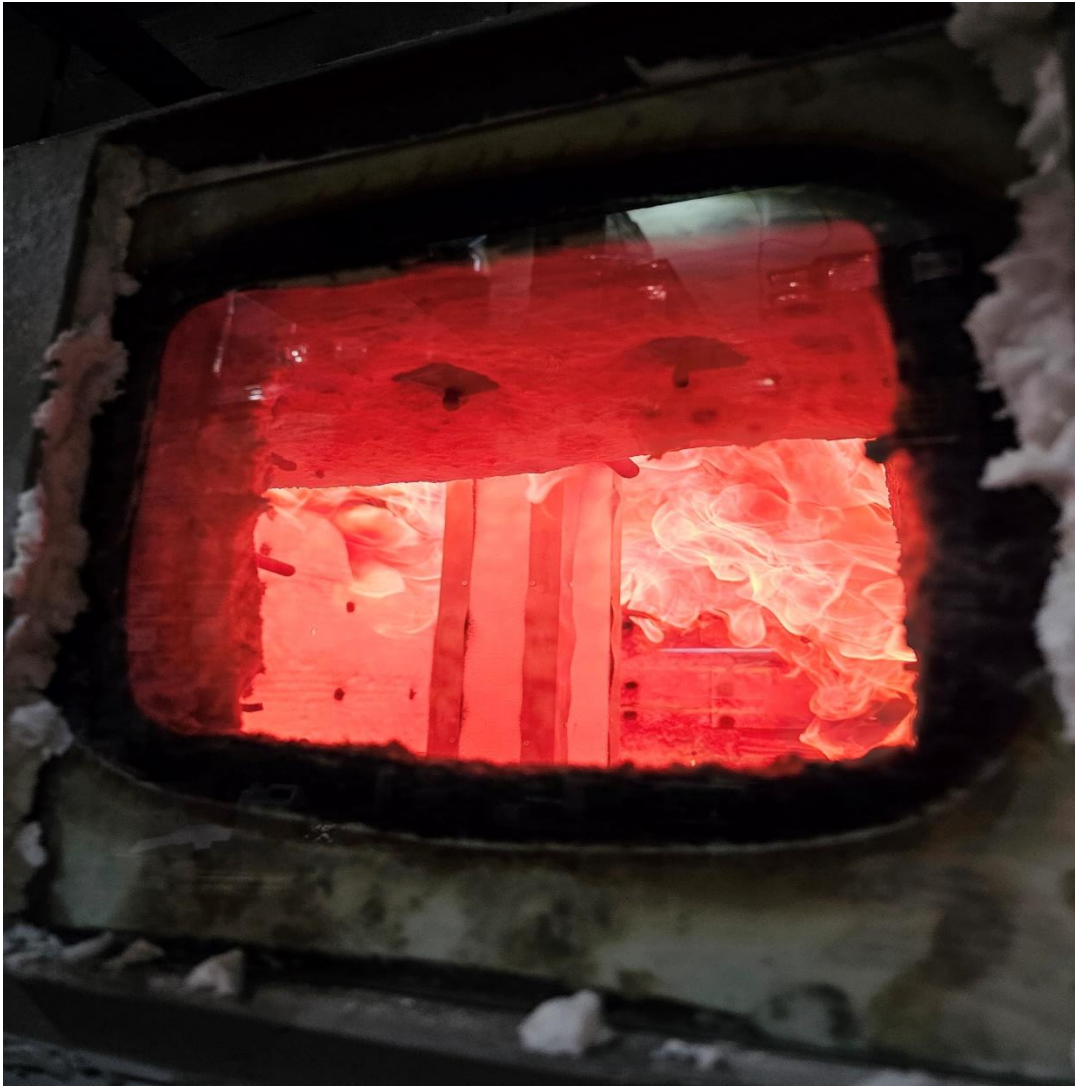
Figure 11. CLT Assembly with Gypsum Protected HSS Steel Column During Fire Exposure

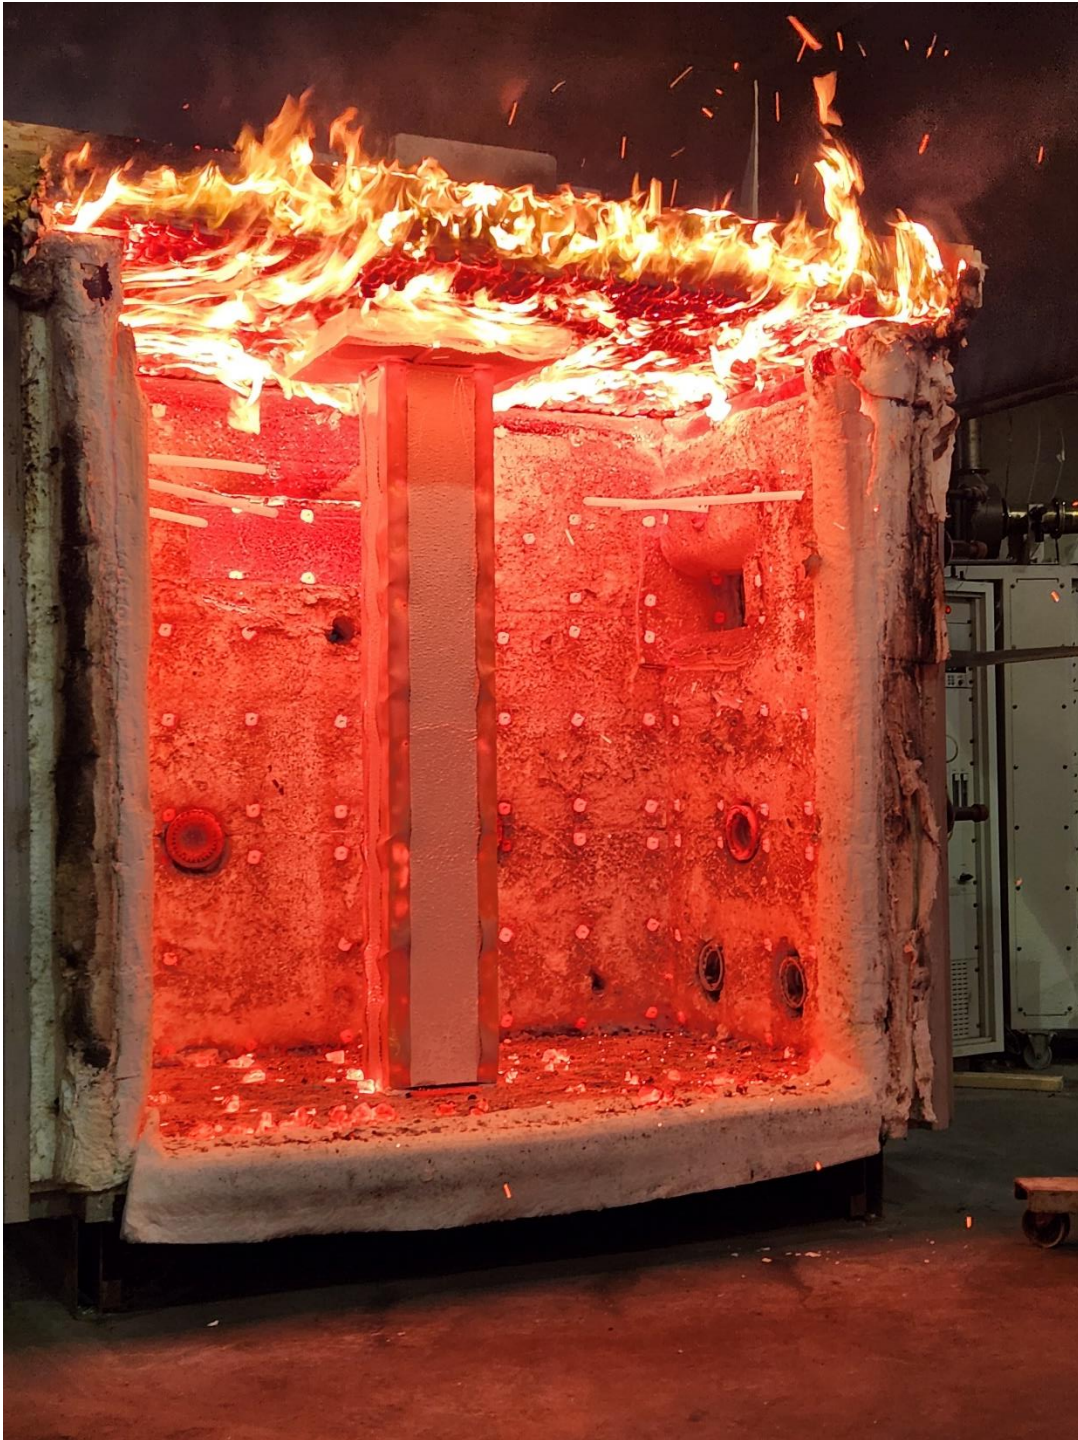
Figure 12. CLT with Gypsum Protected HSS Steel Column Including Corner Flashing After Fire Endurance Exposure

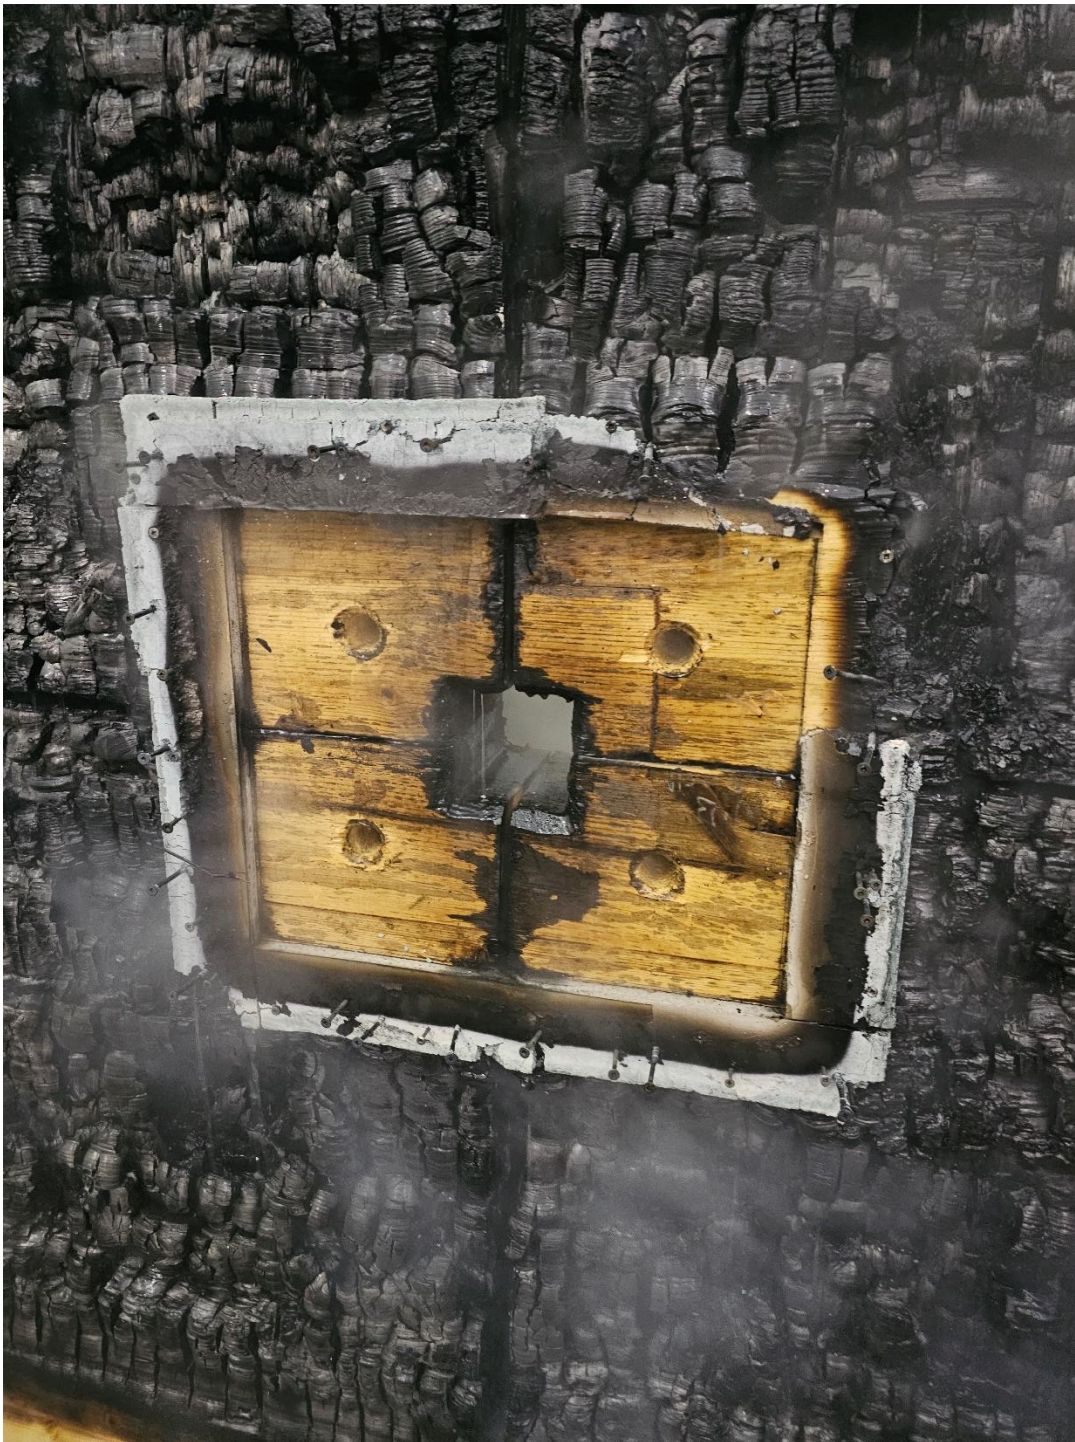
Figure 13. Fire side at HSS steel column penetration with steel plate removed.
